# Manhole Inspection Summary

Manhole # S33A\_\_044MH

**Location** Address: **611 PARK AVE** Cross Street: **MONUMENT ST**

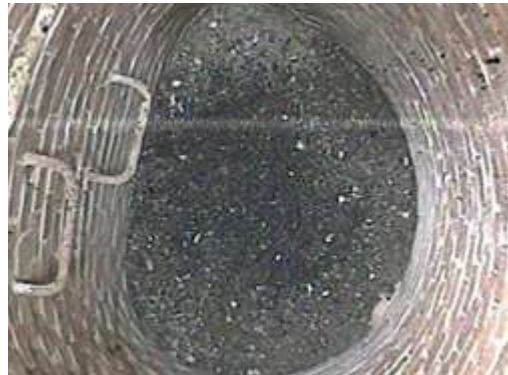
Top View

DEBRIS IN CHANNEL

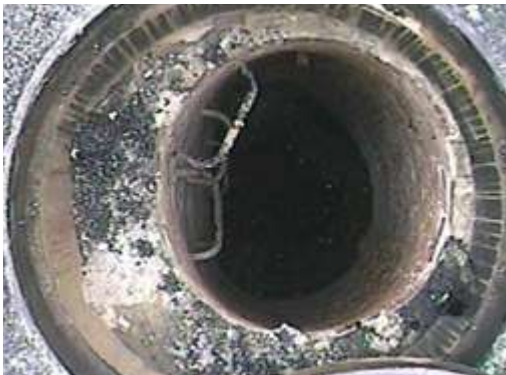
Top View

**Frame** Offset: **6** (in.) Condition: ☒ Sound ☐ Cracked ☐ Leaks

FRAME OFFSET

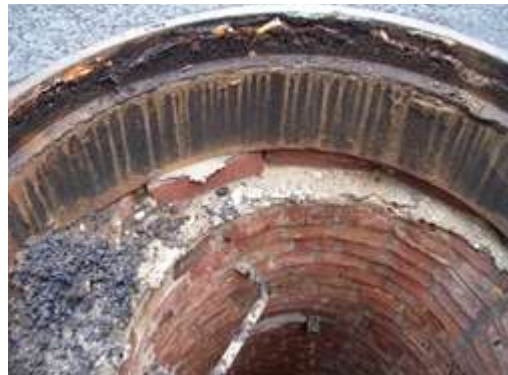
Defect 2

Condition: ☐ Sound ☒ **Cracked** ☐ Root Intrusion ☐ Loose Brick ☐ Deteriorated

CRACKED CHIMNEY/FRAME  
ADJUSTMENT

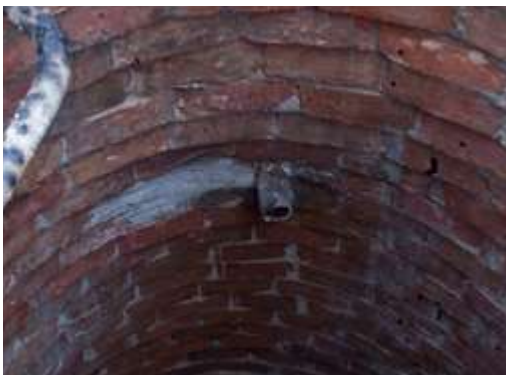
Defect 1

POSSIBLE ILLICIT CONNECTION

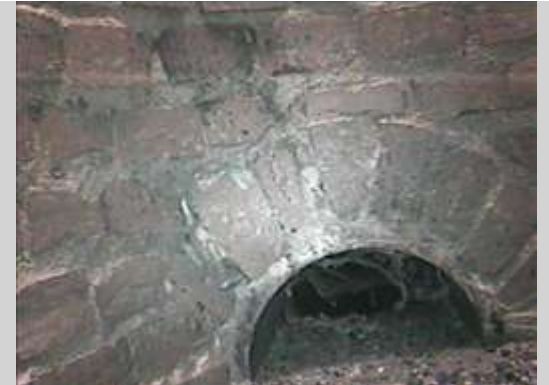
12 O'Clock Outflow

10 in. Circular Gravity Sewer  
Pipe Out @ 12 O'Clock

Deposits: ☐ None ☐ Mud ☐ Sludge ☒ **Debris** ☐ Grease

Silt Depth: **7** (in.) Deposits Extent: **Heavy**
